Roof Inspection

Roof Type: **Three Tab Asphalt Composition Shingles & Modified Bitumen Roof, MBR** Approx. Age: **25 years**
 Layers: **1 layer**
 Approx. Slope(s): **6:12 & low slope**

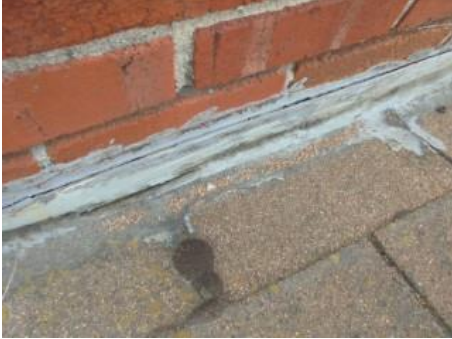
PHOTO 1

1. Flashings at the chimney have covered shingles and sealant applied to protect from water entry is deteriorated – see Photo 1.
2. Two repairs have been provided at the right which have not been applied in accordance with accepted roofing practices and have not been properly integrated into the roof – see Photo 2. The underlying felt paper is improper, there are exposed nails that can allow water entry, and the side laps of the replacement shingles is improperly aligned.

1. Due to the age and condition of the roof, we do not believe repairs would be cost effective nor reliable in the long term from protecting the home from water entry or damage. We recommend having the roof replaced at this time to ensure the home receives reliable protection from water entry and damage. A separate cost estimate to replace the roof can be supplied upon request. Call our office for further assistance.

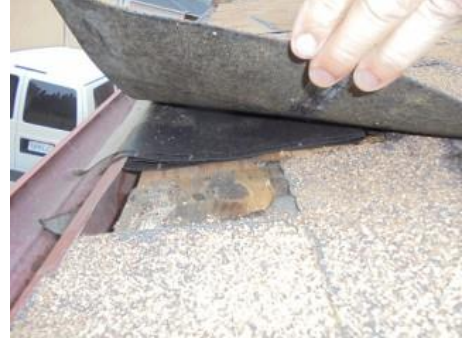
PHOTO 3

3. Where shingles can be lifted at these repairs, we can see bare plywood sheathing exposed to potential damage – see Photo 3.
4. The shingles are experiencing moderate to excessive granule loss where the fiberglass base mat of the shingle panels becomes exposed which will accelerate deterioration of the shingles – see Photo 4.

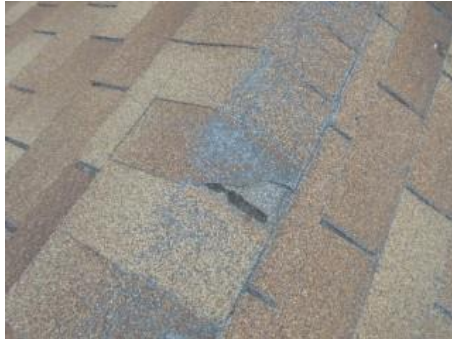
PHOTO 5

5. There are a few displaced ridge shingles – see Photo 5.
6. Flashings have been installed over shingles at roof penetrations and sealant applied to prevent water entry is deteriorated – see Photo 6.

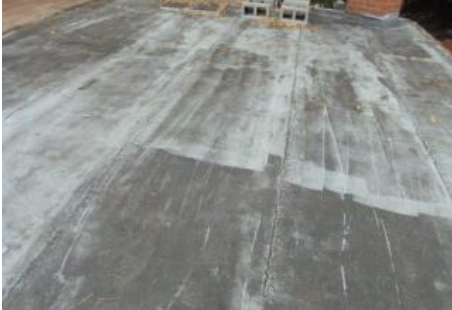
PHOTO 7

7. The aluminized coating on the MBR is completely deteriorated which has allowed portions of the roof surface to become deteriorated as well – see Photo 7.

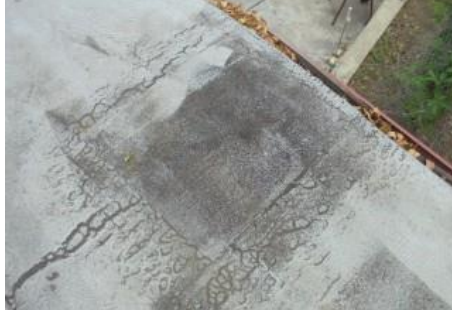
PHOTO 8

8. Previous repairs have been provided to the MBR – see Photo 8.
9. There are voids at the perimeter of the MBR that can allow water entry and the flashing is lifting around the perimeter at various locations – see Photos 9 & 10.
